DRAFT M E M O R A N D U M

DATE: May 16, 2005
TO: Kate Bolton
COMPANY: University of California, Berkeley – Capital Projects
FROM: Andrew Collison
COPY TO: Jorgen Blomberg, PWA
Jeffrey Haltiner, PWA
RE: Winter Creek Geomorphic Assessment - DRAFT
PWA Ref. #: 1773.00 - Winter Creek Stabilization and Enhancement Project

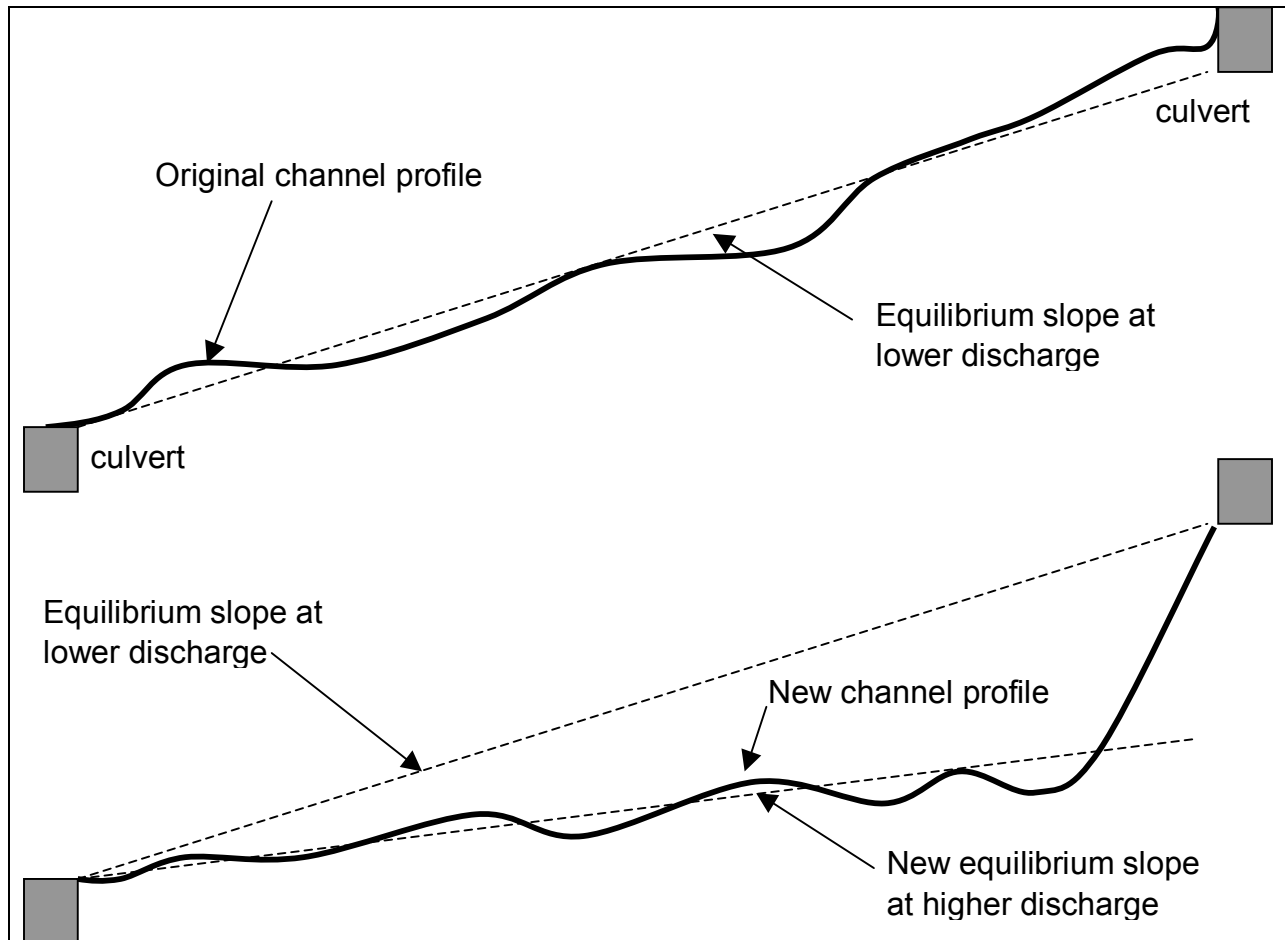
Channels with erodible beds and banks adjust (by erosion and deposition) until they have a shape and gradient that is in equilibrium with their sediment and water inputs from upstream (Figure 1). Equilibrium is defined by a balance of erosion and deposition over a long period of time that results in no net change in bed volume and slope. When the water or sediment inputs are altered the channel adjusts to equalize the energy imbalance. Based on our hydrologic assessment of the watershed (PWA, 2005) urbanization/ land use change appears to have increased peak flows by approximately 30% during the five-year flood. When water inputs to a creek reach increase (increasing energy) the typical channel response is to downcut until the channel has created a lower gradient, absorbing the surplus energy and so regaining geomorphic equilibrium. Since the downstream culvert at Centennial Drive forms a fixed point (grade control) for the channel, the adjustment ‘hinges’ upstream above this point. We expect that increased and ongoing incision will occur upstream away from the culvert until a new hard point is reached.

Figure 1. The equilibrium slope concept.
